## SawADD Performance

## Saw ADD on Small Log High Speed Line

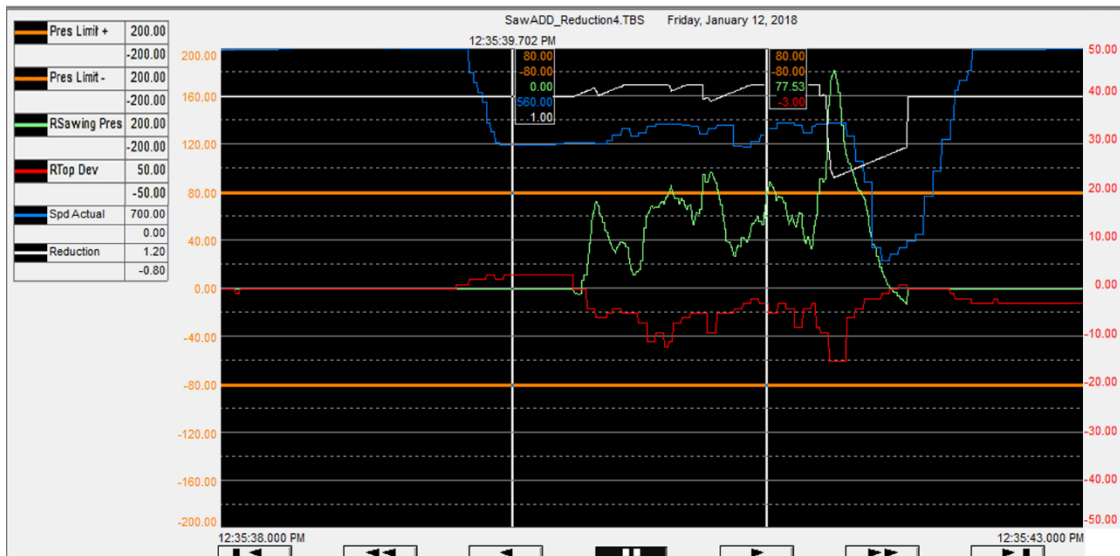
The following trend is an example of a typical log with SawADD speed control. It shows only one saw for simplicity, the right saw,

- leading pressure sensor green,
- top guide deviation sensor red,
- pressure limits orange,
- SawADD speed reduction multiplier white and
- actual speed from the drive blue.

The speed multiplier allows a speed increase after entering the cut by a percent Speed Adder parameter, in this case 5%. Each time the pressure exceeds the limit the reduction is proportional to the amount over limit. When the pressure decreases the speed is allowed to increase at a controlled accel rate. The reduction is at a decel rate as high as the drive will controllably allow. This will reduce peaks in deviation and bring it down quickly.

The top guide sensor will not see the maximum deviation which occurs closer to the bottom of the cut as the saw progresses through the cut meeting resistance and the gullet becoming packed. The SawADD senses pressure on the bottom guide which is closer to the point of maximum deviation.

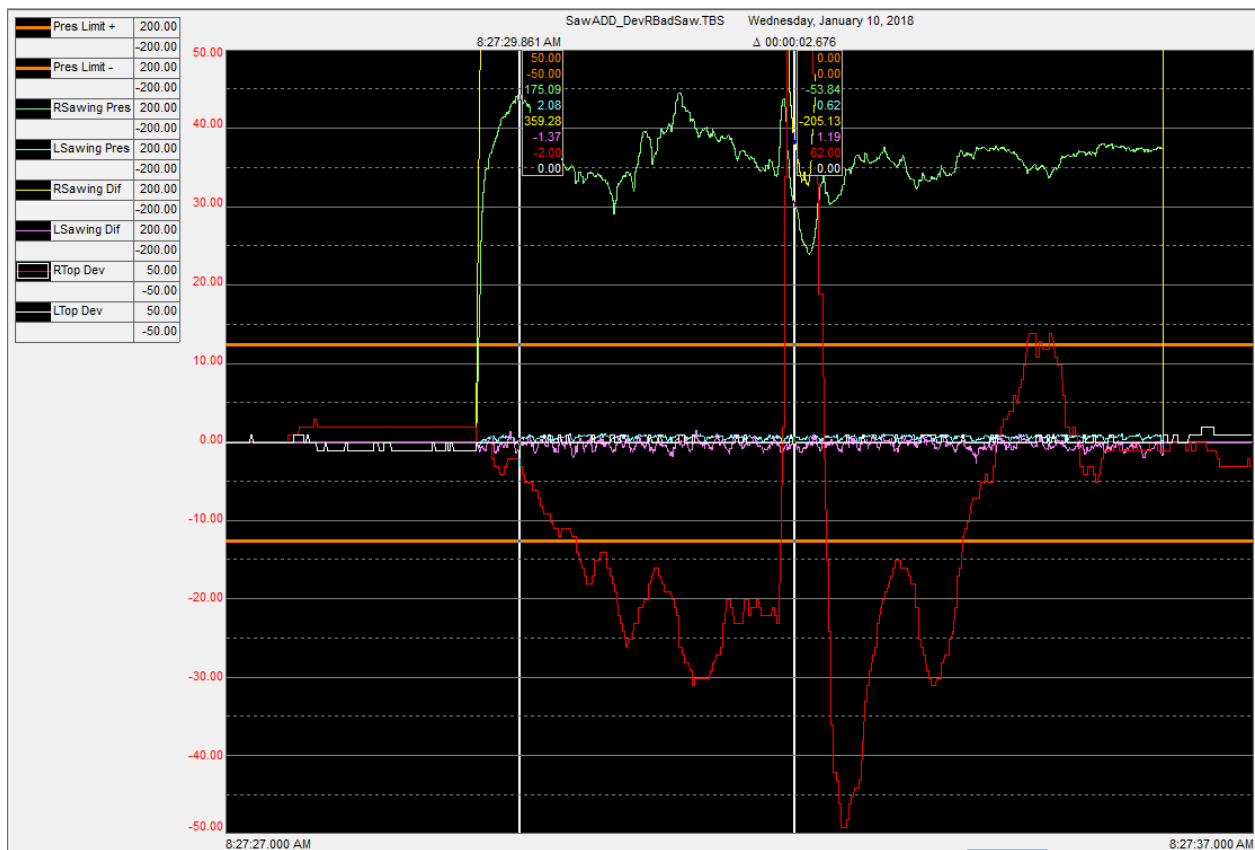
This smoking gun trend captured an example of how the fast response, high resolution and high deceleration rate, may have saved a saw from wrecking. The SawADD pressure in green can be seen to rise to a maximum of 175 lbs. in 0.428 seconds and the front/rear differential in yellow off the chart to 359.

The Top guide sensor in red is showing a minus 2.0 thou at the same instant. Although actual speed was not captured (because of limitation of data on one trend) the SawADD speed control was on and decelerating the feed speed at the maximum rate of the drive, 905 ft/min/sec. At that rate if the feed speed was at 500 ft/min entering the log then it would have decelerated to 30% or 150 ft/min, which was the setting at the time for max reduction allowed.

The Top guide sensor in red shows the deviation continued to rise even at 150 ft/min and reaches minus 30 thou before it jumps to 62 thou positive 2.676 seconds later (for this to happen the log must have rolled) and then back to almost minus 50 thou. For this to happen at about 150 ft/min I believe that at 500 ft/min there would have been a saw wreck. This shows very clearly that pressure is seen first and then deviation increases over time.

The deviation seen by the top guide sensor is never the largest deviation in the cut because the point of measurement (where the sensor is mounted) is close to the top guide. The blade bends away from the guide on an angle pivoting from the guide. The deviation increasing through the cut only allowing a small portion to be seen near the guide.

It should be noted that the time stamp on the trends is for the time zone they were reproduced which is Pacific Coast, not where they are generated and saved. The time in Blue Ridge would be one hour later.

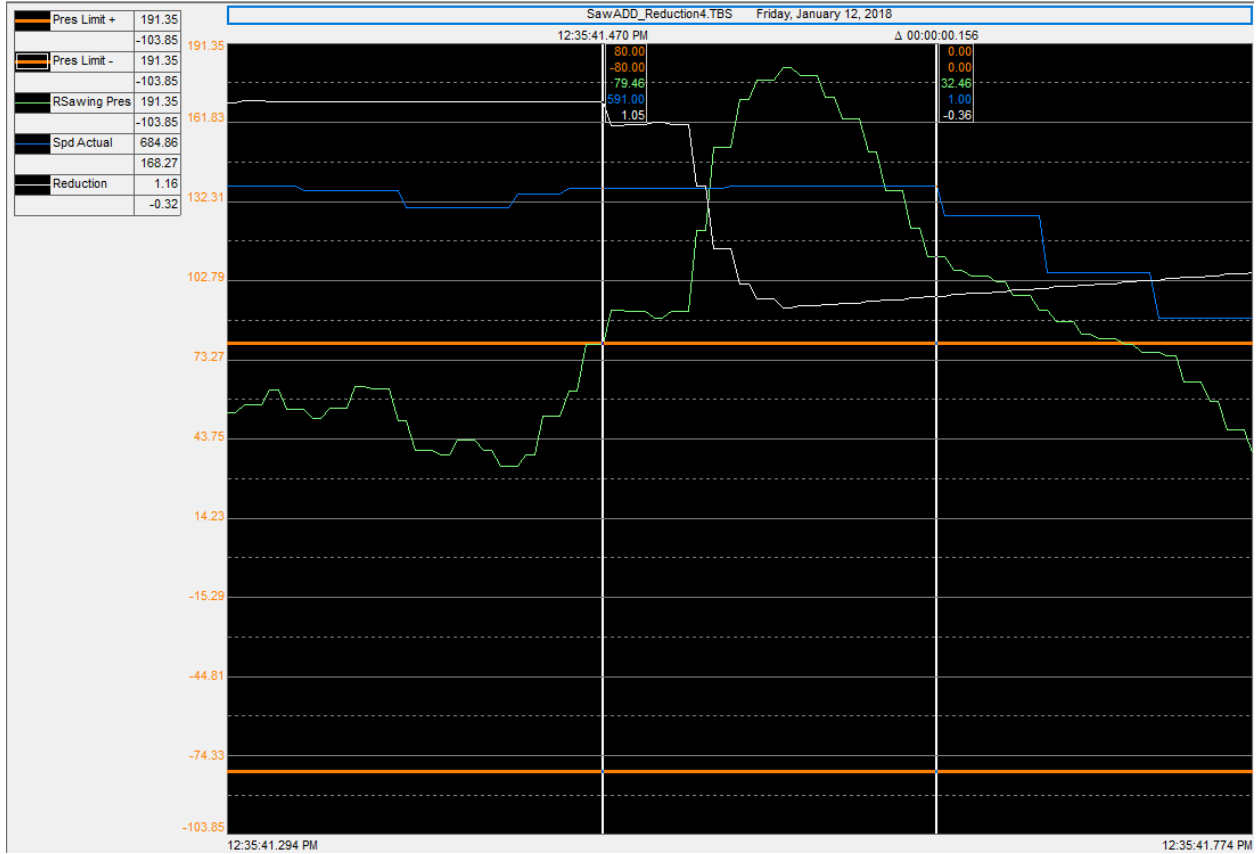
This trend shows the lag between the SawADD reduction in white and the actual speed measured by the drive to be 156 msec. Since the drive communication is in both direction and the drive must sense the speed to returned it to the PLC, the actual speed change probably happens in half the time, 78 msec.

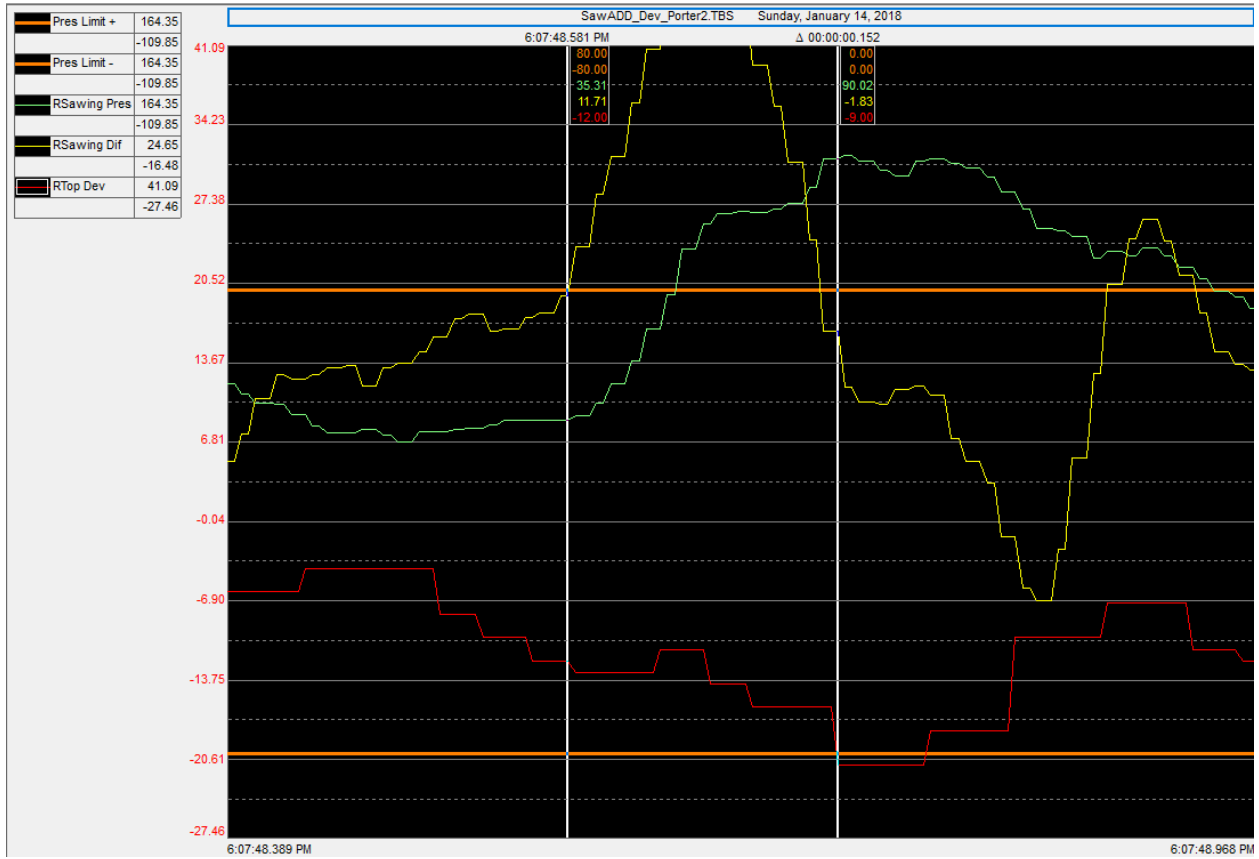
The following trend show the lead of 152 msec when using the differential in yellow (between the front and rear SawADD sensor) to reduce speed, before the Top Guide sensor exceeds 20 thou.
